**Flood Control Project Maintenance
Levee Inspections**

Maintenance Issue Types Only, Levee Inspection Report By Mile - Fall 2019

Reclamation District No. 2060 Hastings

Waterway	Bank	Unit Miles	Inspection Start/End	Inspector
Unit No. 01 Lindsey Slough	Left	6.97	10/15/2019 10/15/2019	David Julian

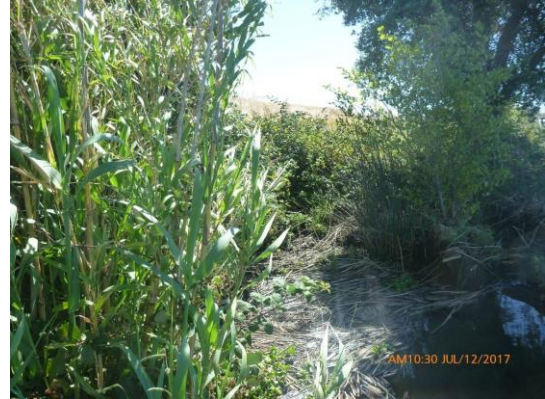
Photo 1 of 6 : FA_2019_RD2060_241_5_20190826_00001.jpg

LM Start	0.40	Rating **	M	Issue No.	5
LM End	0.40	Issue Type +	Ma	Location *	WS
Category	Supplemental			GPS Latitude/Longitude	
				Start	End
Item	2017 Storm Damage			38.247894 °	38.247911 °
				-121.703492 °	-121.703539 °
DWR ID	LMA-185				
Comment Code					
Inspector Comment					
Levee Evaluation Comments					
Description:Erosion commences approximately 3/4 of the way down the slope, near the water line towards the waterside toe.					
Site ID No:358					
Site Designation:LMA-185					
Repair Type: Erosion					
Rating:Area of Concern					
Field Date:7/12/2017					
Notes: Small erosion into bank.

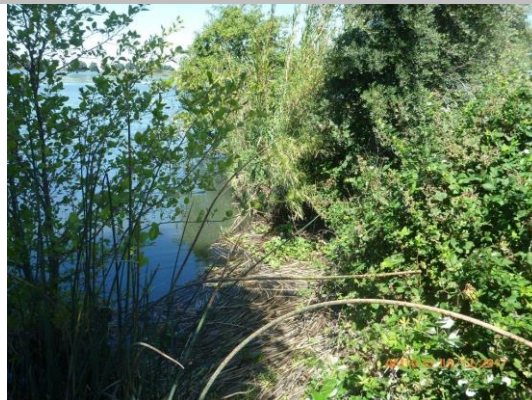
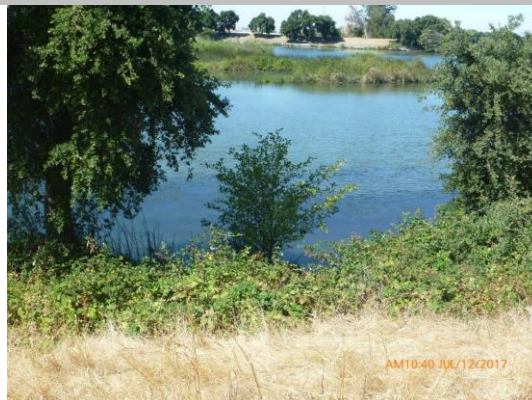
Photo 4 of 6 : FA_2019_RD2060_241_5_20190826_00004.jpg

LM Start	0.40	Rating **	M	Issue No.	5 (cont)	
LM End	0.40	Issue Type +	Ma	Location *	WS	
Category	Supplemental			GPS Latitude/Longitude		
				Start		End
Item	2017 Storm Damage			38.247894 °		38.247911 °
				-121.703492 °		-121.703539 °
DWR ID	LMA-185					
Comment Code						
Inspector Comment						
Levee Evaluation Comments						
Description:Erosion commences approximately 3/4 of the way down the slope, near the water line towards the waterside toe.						
Site ID No:358						
Site Designation:LMA-185						
Repair Type: Erosion						
Rating:Area of Concern						
Field Date:7/12/2017						
Notes: Small erosion into bank.

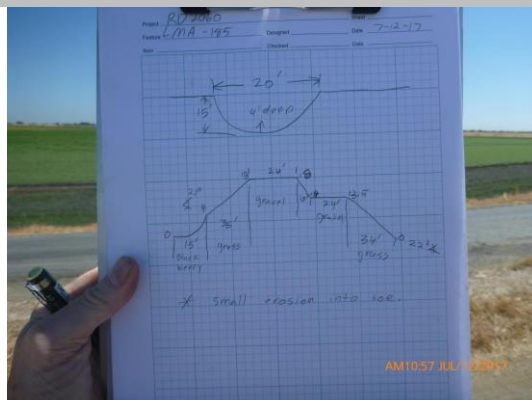
Photo 6 of 6 : FA_2019_RD2060_241_5_20190826_00006.jpg

LM Start	0.40	Rating **	M	Issue No.	5 (cont)	
LM End	0.40	Issue Type +	Ma	Location *	WS	
Category	Supplemental			GPS Latitude/Longitude		
				Start		End
Item	2017 Storm Damage			38.247894 °		38.247911 °
				-121.703492 °		-121.703539 °
DWR ID	LMA-185					
Comment Code						
Inspector Comment						
Levee Evaluation Comments						
Description:Erosion commences approximately 3/4 of the way down the slope, near the water line towards the waterside toe.						
Site ID No:358						
Site Designation:LMA-185						
Repair Type: Erosion						
Rating:Area of Concern						
Field Date:7/12/2017						
Notes: Small erosion into bank.

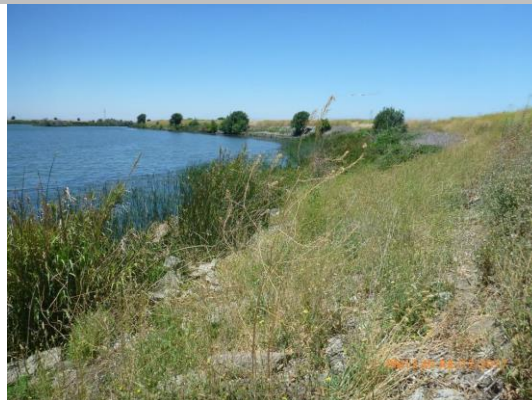
Photo 4 of 4 : FA_2019_RD2060_241_10_20190826_00016.jpg

LM Start	0.92	Rating **	M	Issue No.	10 (cont)
LM End	0.93	Issue Type +	Ma	Location *	WS
Category	Supplemental			GPS Latitude/Longitude	
				Start	End
Item	2017 Storm Damage			38.250875 °	38.250953 °
				-121.711942 °	-121.712078 °
DWR ID	LMA-188				
Comment Code					
Inspector Comment					
Levee Evaluation Comments Description:Sloughing commences approximately halfway down the water side slope. Site ID No:361 Site Designation:LMA-188 Repair Type: Erosion Rating:Area of Concern Field Date:7/12/2017 Notes: Minor sloughing, mostly riprap has moved down the slope and into channel.

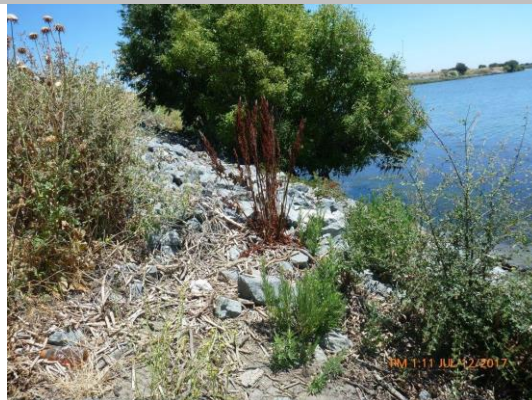
LM Start	1.04	Rating **	M	Issue No.	15
LM End	1.08	Issue Type +	Ma	Location *	WS
Category	Supplemental			GPS Latitude/Longitude	
				Start	End
Item	2017 Storm Damage			38.251058 °	38.250872 °
				-121.714050 °	-121.714792 °
DWR ID	LMA-189				
Comment Code					
Inspector Comment					
Levee Evaluation Comments					
Description:Erosion commences approximately 3/4 of the way down the water side slope concentrated at the waterline.					
Site ID No:362					
Site Designation:LMA-189					
Repair Type: Erosion					
Rating:Area of Concern					
Field Date:7/12/2017					
Notes: Erosion due to lack of revetment. Erosion ends at riprap downstream. Vertical cut at summer wse.

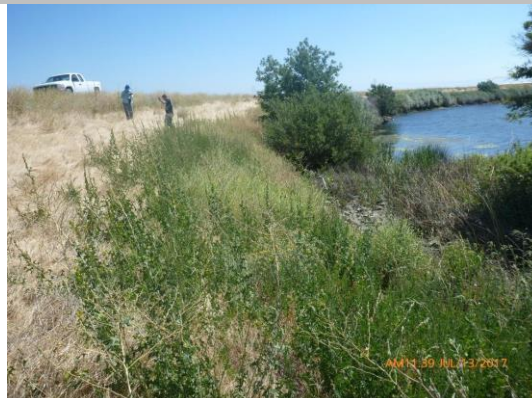
LM Start	3.07	Rating **	A/W	Issue No.	25 (cont)
LM End	3.10	Issue Type +	Ma	Location *	WS
Category	Supplemental			GPS Latitude/Longitude	
				Start	End
Item	2017 Storm Damage			38.260772 °	38.260569 °
				-121.740817 °	-121.741194 °
DWR ID	LMA-197				
Comment Code					
Inspector Comment					
Levee Evaluation Comments					
Description:Erosion occurs near the waterline. Part of the levee has sloughed down toward the waterline due to erosion.					
Site ID No:370					
Site Designation:LMA-197					
Repair Type: Erosion					
Rating:Serious					
Field Date:7/13/2017					
Notes: Large erosion halfway into levee. Horizontal cracking on slope almost 24"deep.

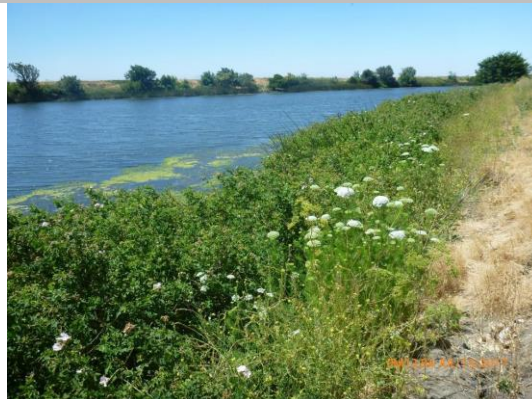
LM Start	3.17	Rating **	M	Issue No.	26
LM End	3.17	Issue Type +	Ma	Location *	WS
Category	Supplemental			GPS Latitude/Longitude	
				Start	End
Item	2017 Storm Damage			38.259925°	38.259903°
				-121.742236°	-121.742281°
DWR ID	LMA-198				
Comment Code					
Inspector Comment					
Levee Evaluation Comments Description:Erosion occurs near the waterline. Site ID No:371 Site Designation:LMA-198 Repair Type: Erosion Rating:Area of Concern Field Date:7/13/2017 Notes: Minor erosion with sloughing. Horizontal cracks 3.5' deep.

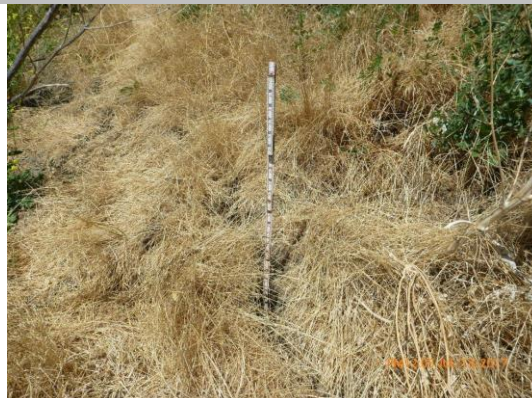
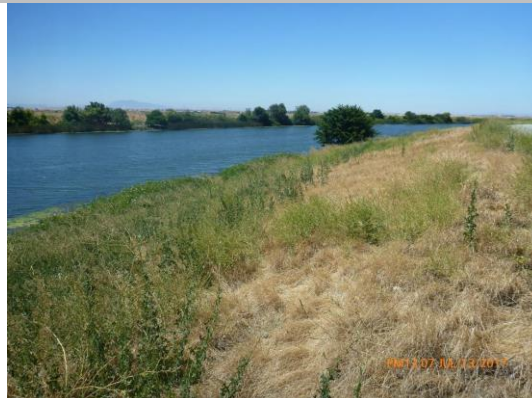
Photo 3 of 3 : FA_2019_RD2060_241_26_20190826_00043.jpg

LM Start	3.17	Rating **	M	Issue No.	26 (cont)	
LM End	3.17	Issue Type +	Ma	Location *	WS	
Category	Supplemental			GPS Latitude/Longitude		
				Start	End	
Item	2017 Storm Damage			38.259925 °	38.259903 °	
				-121.742236 °	-121.742281 °	
DWR ID	LMA-198					
Comment Code						
Inspector Comment						
Levee Evaluation Comments						
Description:Erosion occurs near the waterline.						
Site ID No:371						
Site Designation:LMA-198						
Repair Type: Erosion						
Rating:Area of Concern						
Field Date:7/13/2017						
Notes: Minor erosion with sloughing. Horizontal cracks 3.5' deep.

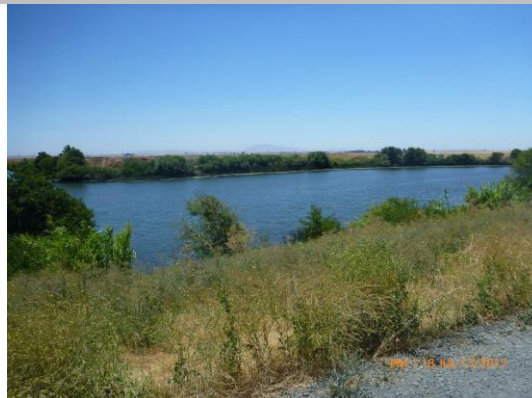
LM Start	3.60	Rating **	M	Issue No.	27 (cont)
LM End	3.61	Issue Type +	Ma	Location *	WS
Category	Supplemental			GPS Latitude/Longitude	
				Start	End
Item	2017 Storm Damage			38.261469 °	38.261464 °
				-121.748389 °	-121.748442 °
DWR ID	LMA-200				
Comment Code					
Inspector Comment					
Levee Evaluation Comments					
Description:Erosion commences halfway down the slope and extends to the toe. Erosion is concentrated at the water line.					
Site ID No:373					
Site Designation:LMA-200					
Repair Type: Erosion					
Rating:Area of Concern					
Field Date:7/13/2017					
Notes: Small erosion with a narrow deep cut. Heavy veg is protecting the slope.

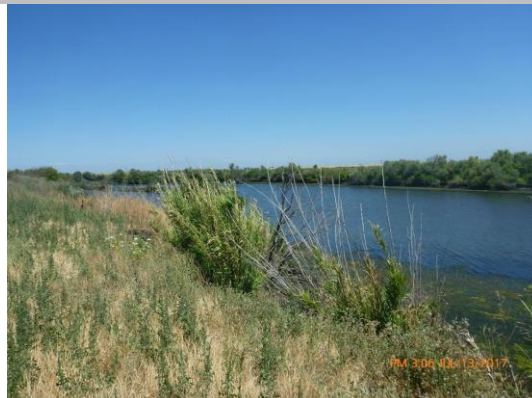
LM Start	4.40	Rating **	M	Issue No.	30 (cont)	
LM End	4.46	Issue Type +	Ma	Location *	WS	
Category	Supplemental			GPS Latitude/Longitude		
				Start	End	
Item	2017 Storm Damage			38.260850 °	38.260425 °	
				-121.761875 °	-121.762861 °	
DWR ID	LMA-204					
Comment Code						
Inspector Comment						
Levee Evaluation Comments						
Description:Erosion/sloughing commences approximately halfway down the slope. Erosion is concentrated mostly near the water line and has resulting in slippage of the slope.						
Site ID No:377						
Site Designation:LMA-204						
Repair Type: Erosion						
Rating:Area of Concern						
Field Date:7/13/2017						
Notes: large cut is 100' of 320' site. Large cut is 12' vertical and the rest is 6'.

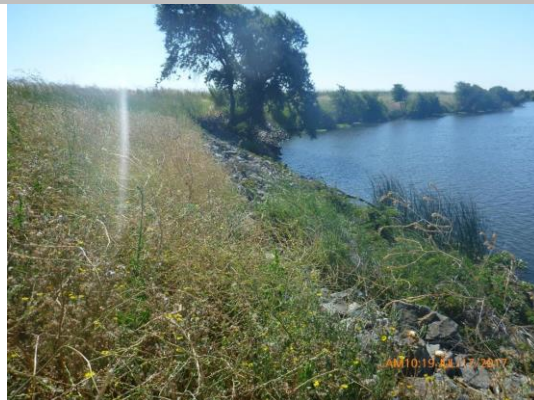
LM Start	4.92	Rating **	M	Issue No.	33
LM End	4.92	Issue Type +	Ma	Location *	WS
Category	Supplemental			GPS Latitude/Longitude	
				Start	End
Item	2017 Storm Damage			38.262128°	38.262128°
				-121.769175°	-121.769175°
DWR ID	LMA-207				
Comment Code					
Inspector Comment					
Levee Evaluation Comments					
Description:Erosion/sloughing commences approximately halfway down the slope. Erosion is concentrated mostly near the water line and has resulting in slippage of the slope into the toe.					
Site ID No:380					
Site Designation:LMA-207					
Repair Type: Erosion					
Rating:Area of Concern					
Field Date:7/17/2017					
Notes: Reduced length of site from 275 to 62. No widespread erosion, just 2 small erosions upstream from adjacent riprap.

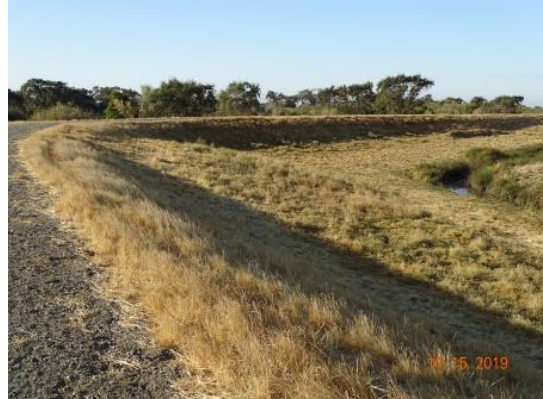
View of annual vegetation on the landside slope (Fall 2019).

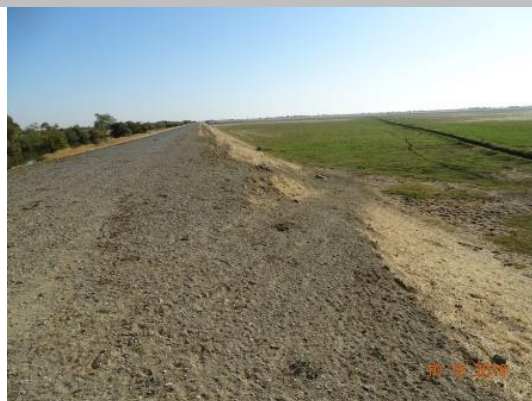
View looking downstream at cow path on the landside slope (Fall 2019).

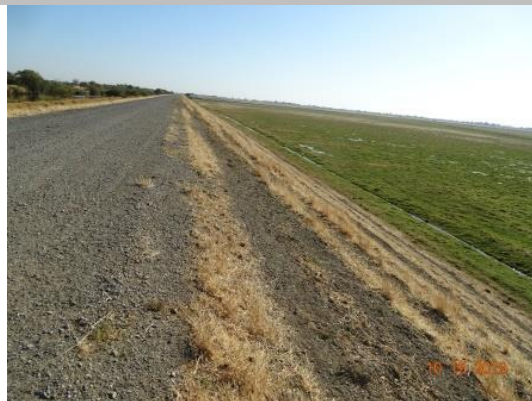
View looking downstream at terracing in the levee due to cows (Fall 2019).

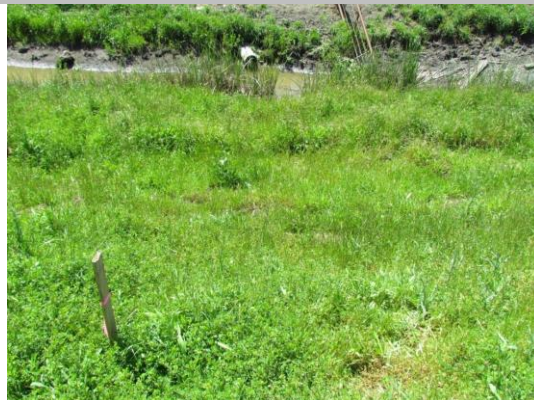
Looking down from the shoulder at the sloughing in the slope towards the irrigation ditch at toe.

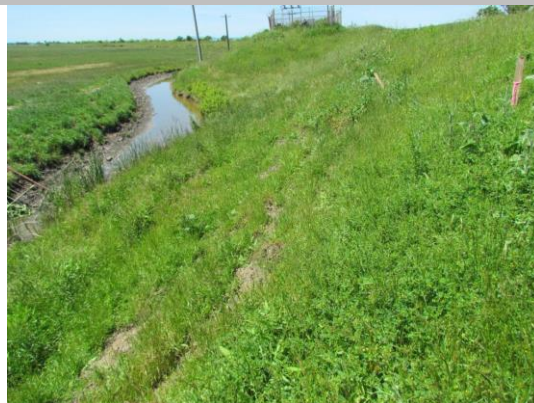
Standing on the slope looking upstream at the slough.

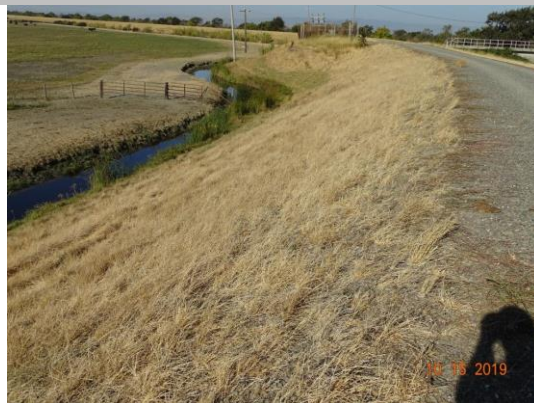
View looking upstream at minor slump on the lower half of the landside slope (Fall 2019).

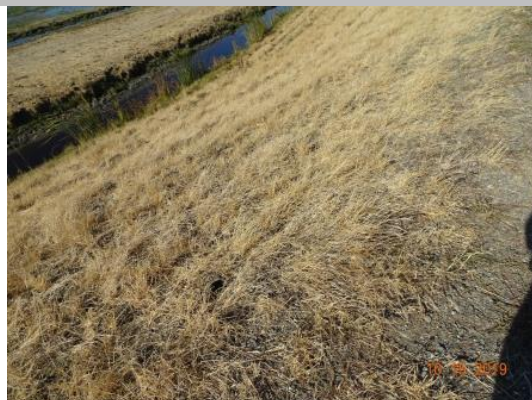
View looking downslope at the erosion site (Fall 2019).

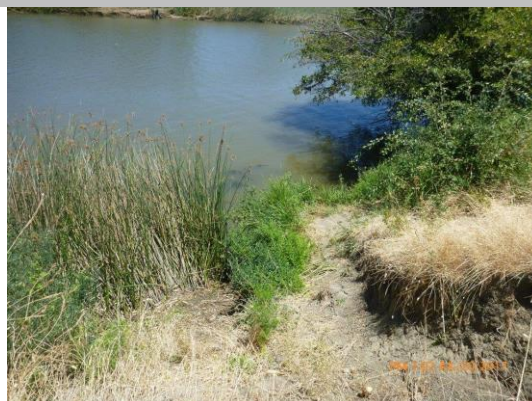
LM Start	0.81	Rating **	M	Issue No.	15
LM End	0.81	Issue Type +	Ma	Location *	WS
Category	Supplemental			GPS Latitude/Longitude	
				Start	End
Item	2017 Storm Damage			38.291633°	38.291606°
				-121.736750°	-121.736714°
DWR ID	LMA-215				
Comment Code					
Inspector Comment					
Levee Evaluation Comments					
Description:Erosion commences approximately 3/4 of the way down the slope. Erosion has resulted in slippage into the waterside toe.					
Site ID No:388					
Site Designation:LMA-215					
Repair Type: Erosion					
Rating:Area of Concern					
Field Date:7/20/2017					
Notes: Narrow erosion on WS slope. Monitor for progression.

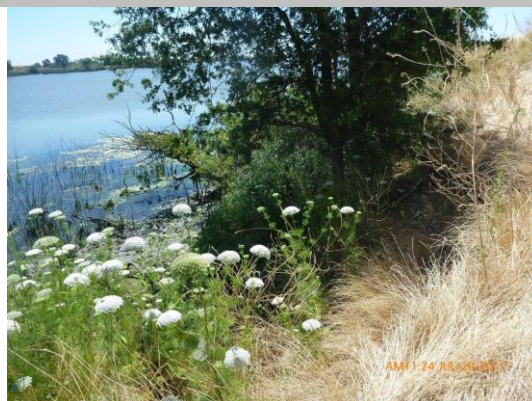
LM Start	1.62	Rating **	A/W	Issue No.	23
LM End	1.63	Issue Type +	Ma	Location *	WS
Category	Supplemental			GPS Latitude/Longitude	
				Start	End
Item	2017 Storm Damage			38.287336 °	38.287222 °
				-121.724364 °	-121.724253 °
DWR ID	LMA-220				
Comment Code					
Inspector Comment					
Levee Evaluation Comments					
Description:Erosion commences halfway down the slope and results in slippage into the waterside toe. Existing rip rap has sloughed into the water side toe.					
Site ID No:393					
Site Designation:LMA-220					
Repair Type: Erosion					
Rating:Serious					
Field Date:7/20/2017					
Notes: Moderate sloughing 8ft from WS crown. Erosion at high water mark.

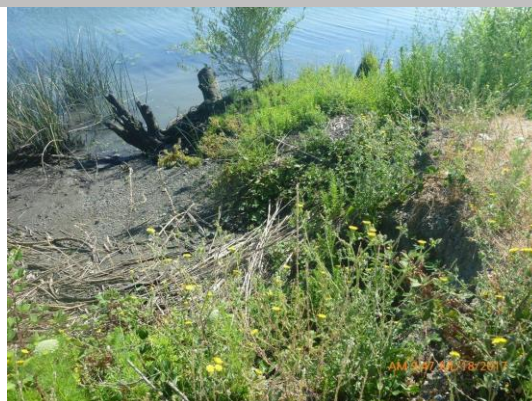
LM Start	3.24	Rating **	M	Issue No.	37
LM End	3.24	Issue Type +	Ma	Location *	WS
Category	Supplemental			GPS Latitude/Longitude	
				Start	End
Item	2017 Storm Damage			38.270231 °	38.270203 °
				-121.705897 °	-121.705856 °
DWR ID	LMA-233				
Comment Code					
Inspector Comment					
Levee Evaluation Comments					
Description:Erosion commences approximately halfway down the slope and results in sloughing into the waterside toe. Existing rip rap has been pulled off the slope at this site.					
Site ID No:406					
Site Designation:LMA-233					
Repair Type: Erosion					
Rating:Area of Concern					
Field Date:7/18/2017					
Notes: Erosion is next to a pumphouse and slope is protected with rip rap.
